Manhole Inspection Summary

Manhole # S11WW_020MH

Insp Date: **7/30/07 11:56 AM**

Location Address: **3300 DORCHESTER RD**

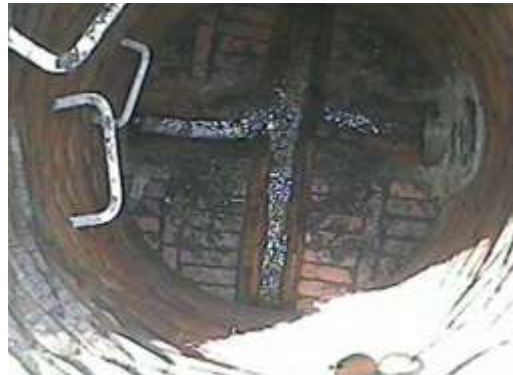
Top View

DEBRIS ON BENCH

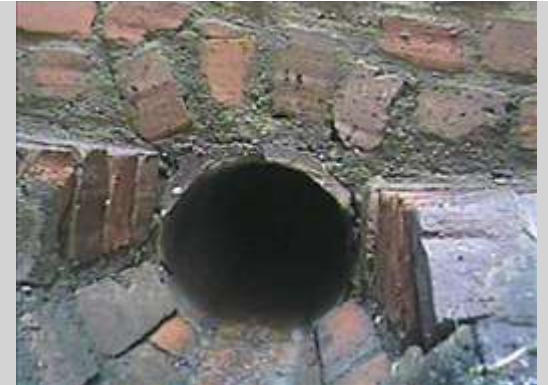
12 O'Clock Outflow

8 in. Circular Gravity Sewer
Pipe Out @ 12 O'Clock

Pipe Height: (in.) Direct
Pipe Material: **Clay** ☐ Pipe Lined
Invert Depth: **8.59** (ft.) Flow Characteristics: **Slow**
Deposits: ☒ None ☐ Mud ☐ Sludge ☐ Debris ☐ Grease
Silt Depth: (in.) Deposits Extent:
Infiltration: **None** Pipe Seal Cond: **Broken**

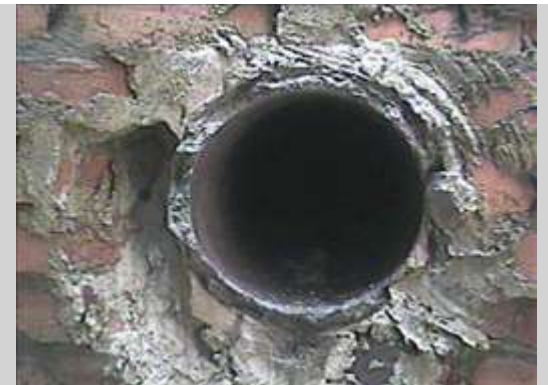
3 O'Clock Inflow

8 in. Circular Gravity Sewer
Pipe In @ 3 O'Clock

Drop In @ 3 O'Clock

Pipe Height: (in.) Direct
Pipe Material: **Clay** ☐ Pipe Lined
Invert Depth: **4.90** (ft.) Flow Characteristics: **Slow**
Deposits: ☒ None ☐ Mud ☐ Sludge ☐ Debris ☐ Grease
Silt Depth: (in.) Deposits Extent:
Infiltration: **None** Pipe Seal Cond: **Broken**

Drop: **Outside Direct**
Angled: Reading: (ft.)
Inv Depth: **6.23** (ft.)

Drop Condition: **Open**

Connects To: **Stub connection / abandoned**

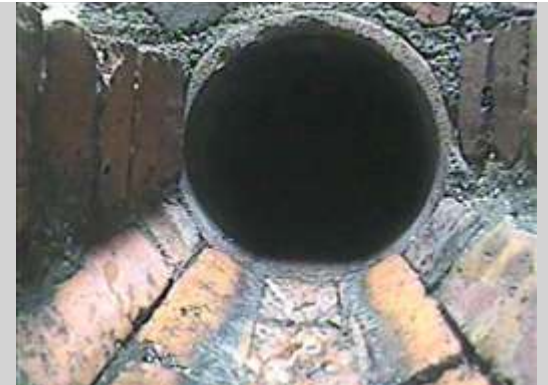
6 O'Clock Inflow

8 in. Circular Gravity Sewer

Pipe In @ 6 O'Clock

Infiltration: **None** Pipe Seal Cond: **Broken**

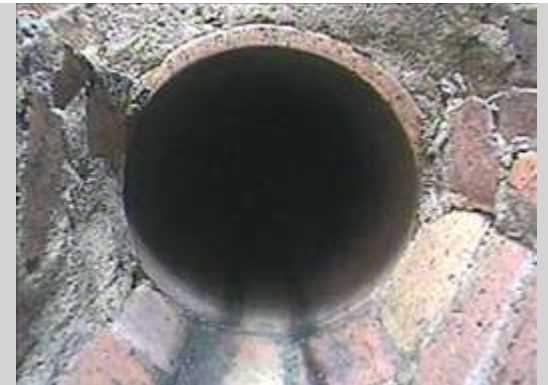
9 O'Clock Inflow

8 in. Circular Gravity Sewer

Pipe In @ 9 O'Clock

Infiltration: **None** Pipe Seal Cond: **Cracked**

Connects To: **Stub connection / abandoned**
